&\$\%\`K?'GFH,'!'MIRROR-INSIDE REARVIEW C1

Harness Family: Mirror_Int_Jumper Harness Part Number: 68079155AC

Part Description: USCAR 20P .64 CONNECTOR ASSY (CLUSTER)

Connector No: D6625A

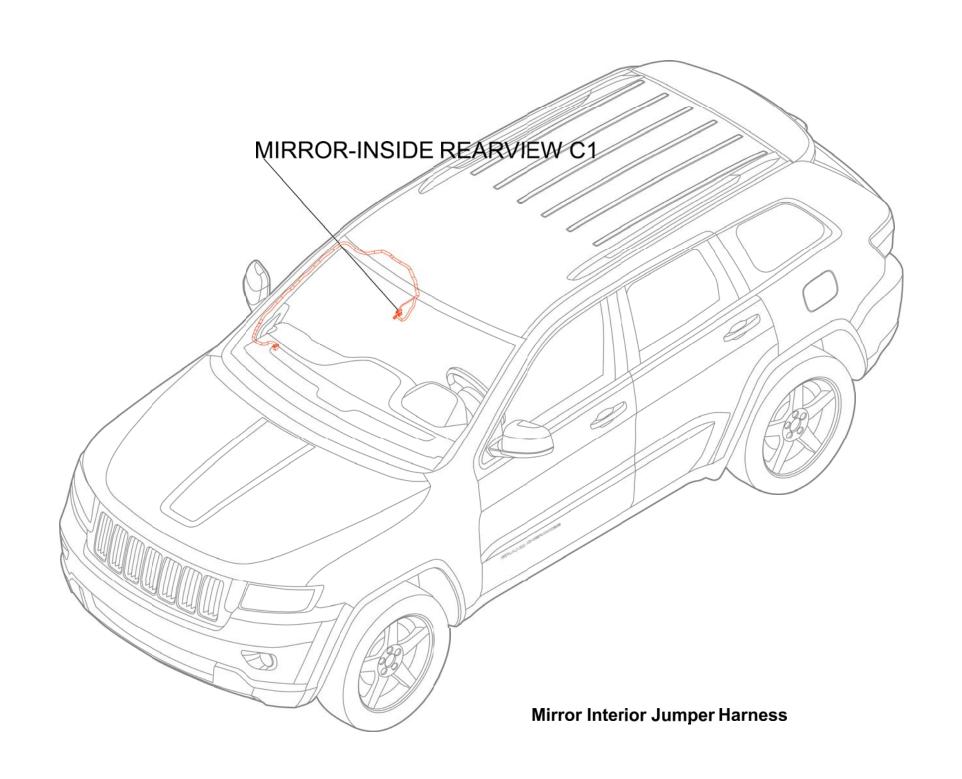
Cavities: 20 Color: BLACK Gender: Female

Seal: Un-Sealed

Pin	Circuit	Wire Color	Gauge	Function
A1	X712	DB/LB	22	MICROPHONE 1 IN (+)
A2	X792	DB/DG	22	MICROPHONE IN (-)
А3	X722	LB/DG	22	MICROPHONE 2 IN (+)
A4				NO CONNECTION
A 5				NO CONNECTION
A6	D265	WT/GY	22	CAN IHS BUS (125K) (+)
A7	D264	WT/OR	22	CAN IHS BUS (125K) (-)
A8	Z912	BK	18	GROUND
Α9	L1	WT/LG	18	BACKUP LAMP FEED
A10	X835	OR/GY	22	SENSOR GROUND
A11				NO CONNECTION
A12				NO CONNECTION
A13	F943	PK/LG	18	FUSED IGNITION RUN-START CONTROL OUTPUT
A14	P112	TN/OR	22	AUTO DAY/NIGHT MIRROR (+)
A15	X793	DG/YL	22	MICROPHONE FEED
A16	P114	TN/WT	22	AUTO DAY/NIGHT MIRROR (-)

A17	NO CONNECTION
A18	NO CONNECTION
A19	NO CONNECTION
A20	NO CONNECTION
