**NUMBER:** 08-089-13

Poor Sirius Satellite Radio Reception

This bulletin involves replacing the satellite antenna if needed.

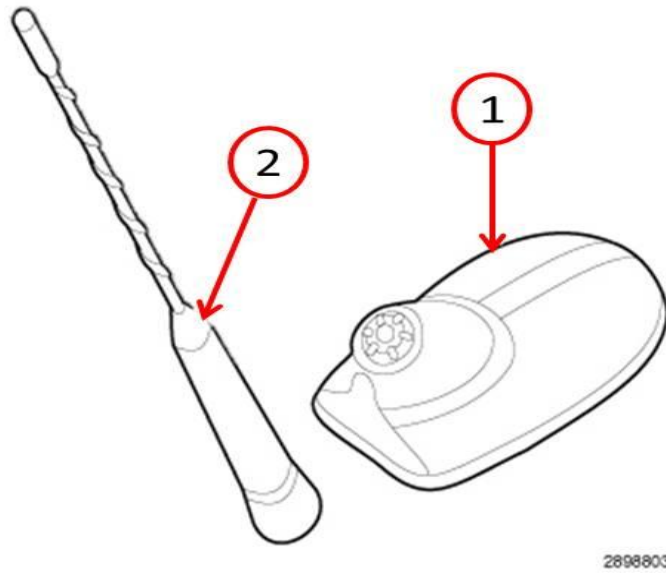
**Fig. 1 Antenna Mast and Base**

1 - Base

2 - Mast

**NOTE: When replacing an antenna that has a screw on mast, the mast does not need to be replaced, see (Fig. 1)**
