NUMBER: 23-005-17

Fuel Door Will Not Open

This bulletin involves filing excess plastic from the fuel filler neck housing.

2016 - 2017 (WK) Jeep Grand Cherokee

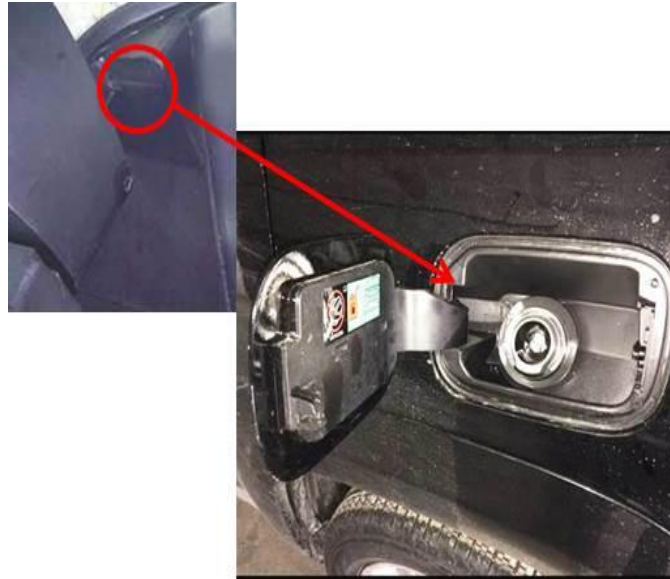
Fig. 1 Fuel Filler Plastic Rib To File

1. Fully open the fuel door.
2. Locate the plastic rib on fuel filler neck housing (Fig. 1).
